Grower: Christine and Erich Gemperle

Crop: Almonds

Location: Ceres, Stanislaus County

On-farm Recharge Pilot Projects Case Study

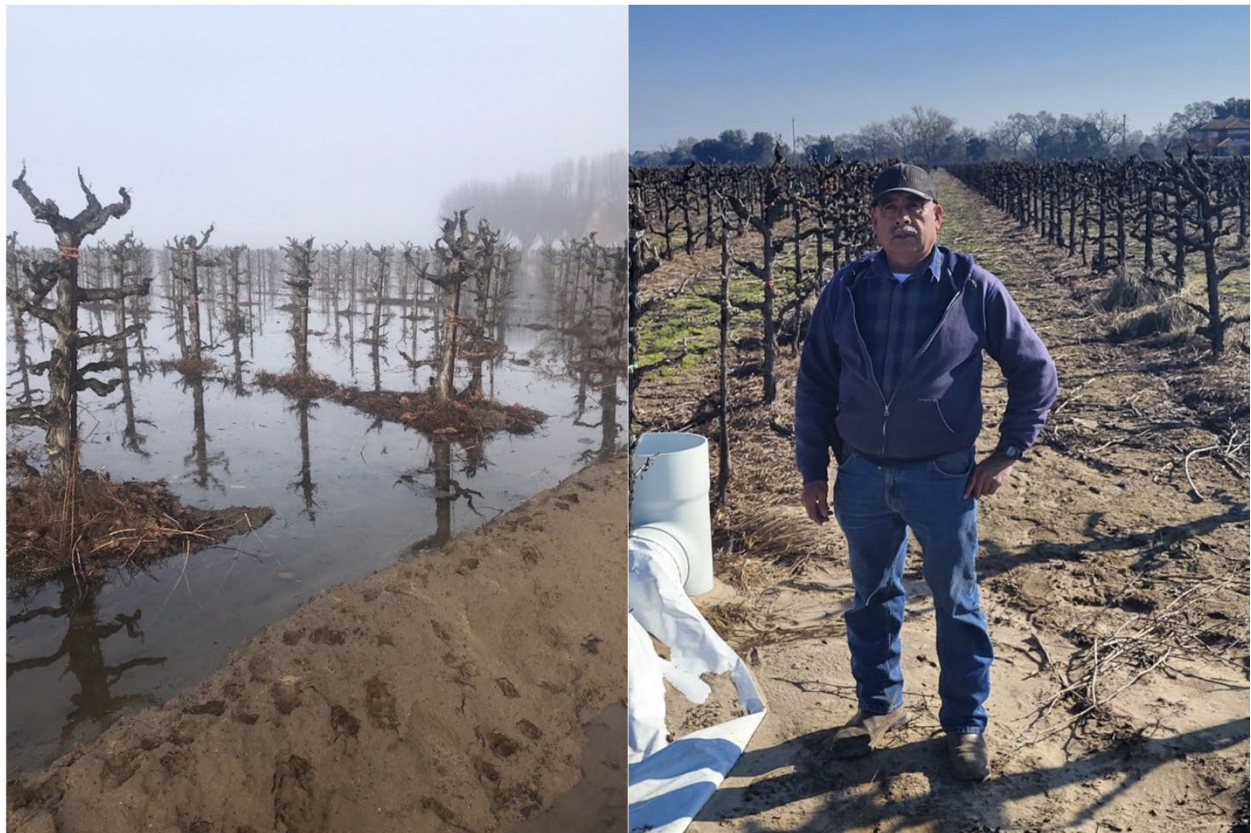
LEFT Photograph: On-farm recharge in mid-January 2022. The water head height is 3–5 inches.

RIGHT Photograph: Jose Luis, the field manager, is standing on the west side of the Costa vineyard where the recharge water is pumped into the field from about 1,500 feet of underground pipe using a lay-flat perforated temporary conveyance pipe, which is connected to risers at the head of the plant line. The field manager handles all of the logistics for successful on-farm recharge without unintended consequences. This picture was taken on January 25, 2023, about two weeks following a flood overflow breach from the Mokelumne River after on-farm recharge efforts in December 2022.

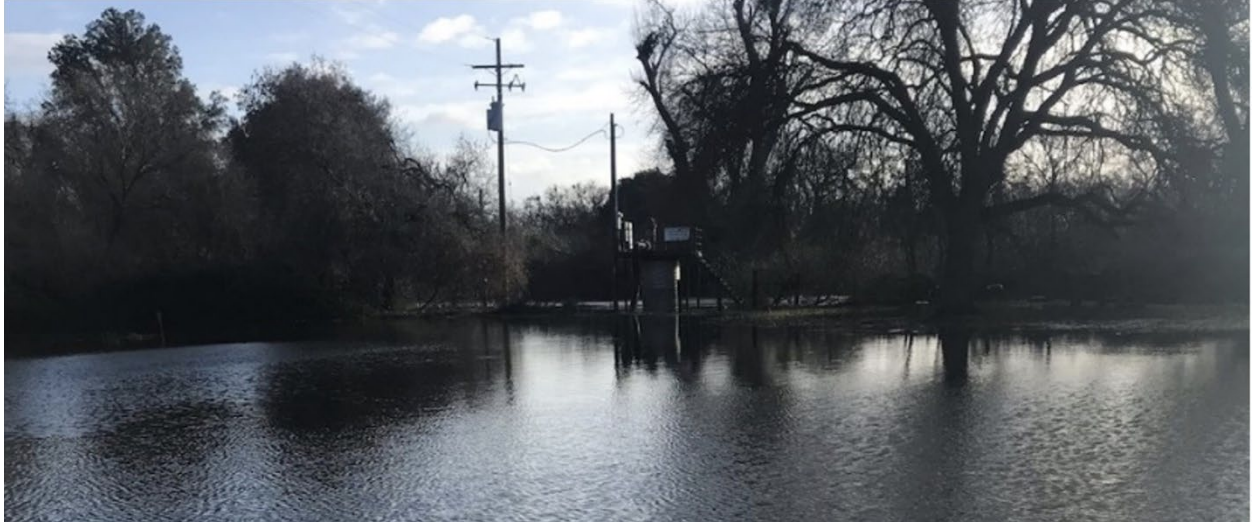
The Mokelumne River is the water supply for the Costa vineyard. But as of early January 2023, all on-farm recharge efforts ceased because of river overflow and flood conditions in Acampo, CA.

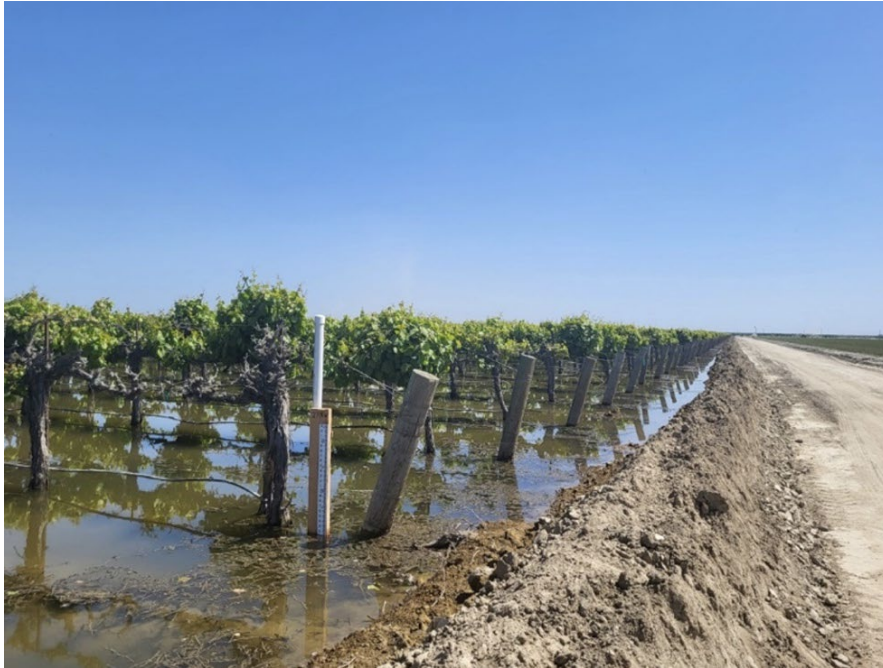
Above photo note: Mr. Cameron started recharging this field in late-March 2023 and has included it in his goal to recharge 30,000 acre-feet at Terranova Ranch. Ruby red wine grapes seen here on April 21, 2023.

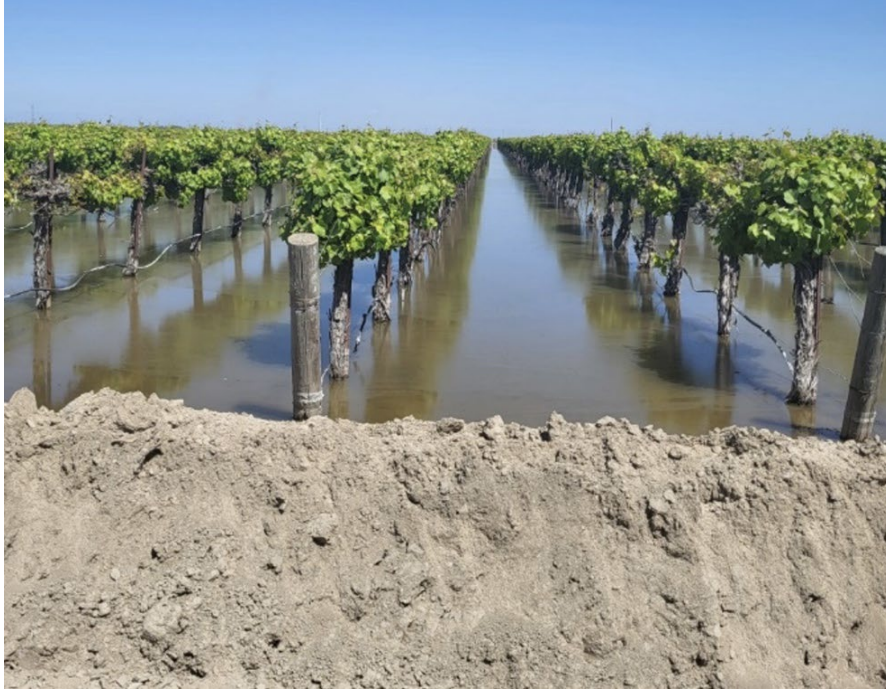
Above photo note: Ruby red wine grapes on-farm recharge in mid-April 2023 with a 3-foot berm on the outer perimeter of the orchard to ensure water stays in the targeted field. The water has a head height of approximately 1 foot.

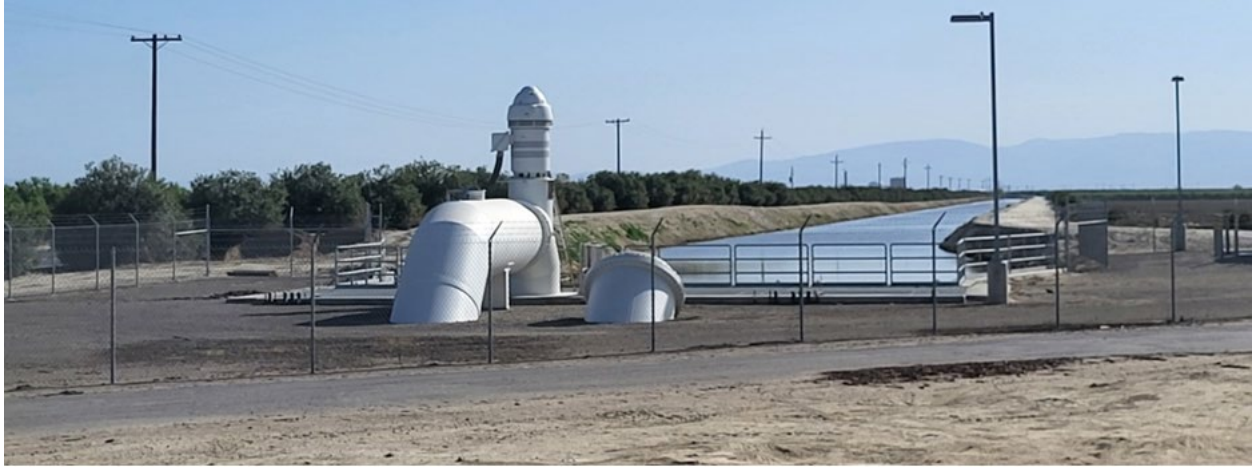
Pump used to divert water from the Kings River at peak flow levels. Maximum pump capacity of 12.5 acre-feet per hour (151 cubic feet per second).

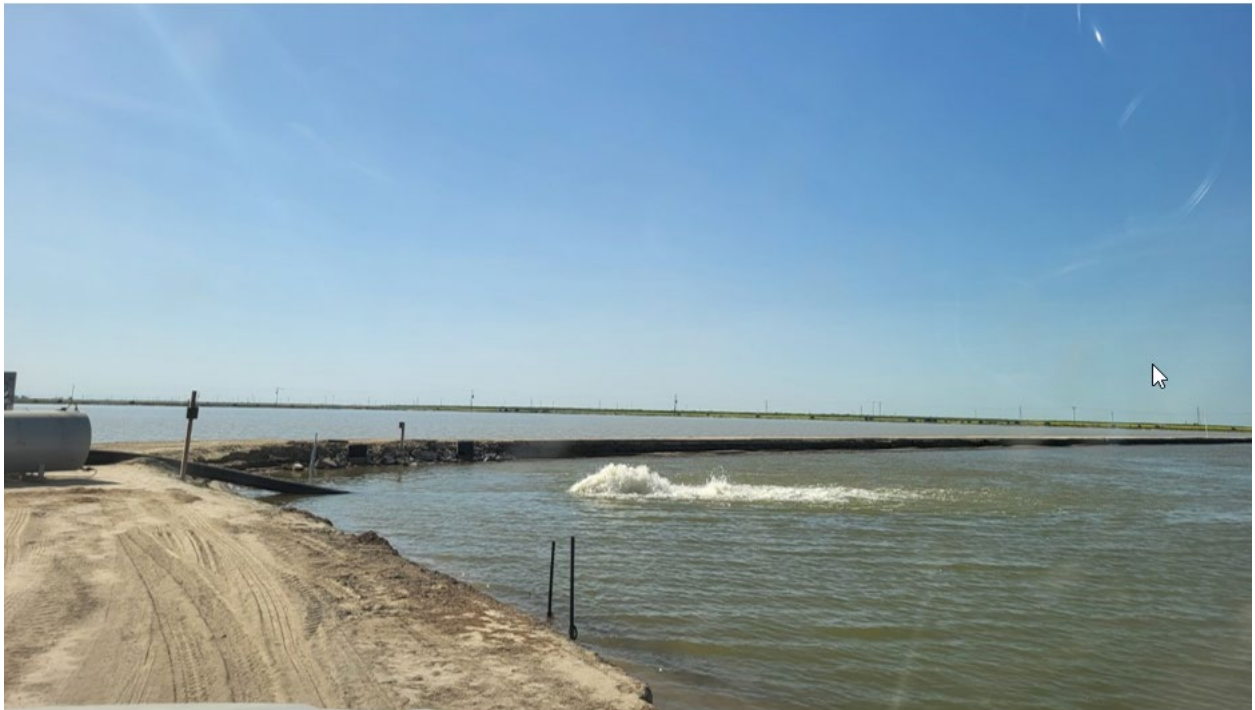
Two of three on-farm recharge unlined recharge basins, each with storage capacity of 50–60 acre-feet. Mr. Cameron has observed a significant increase in shorebird activity in and around the recharge basins.

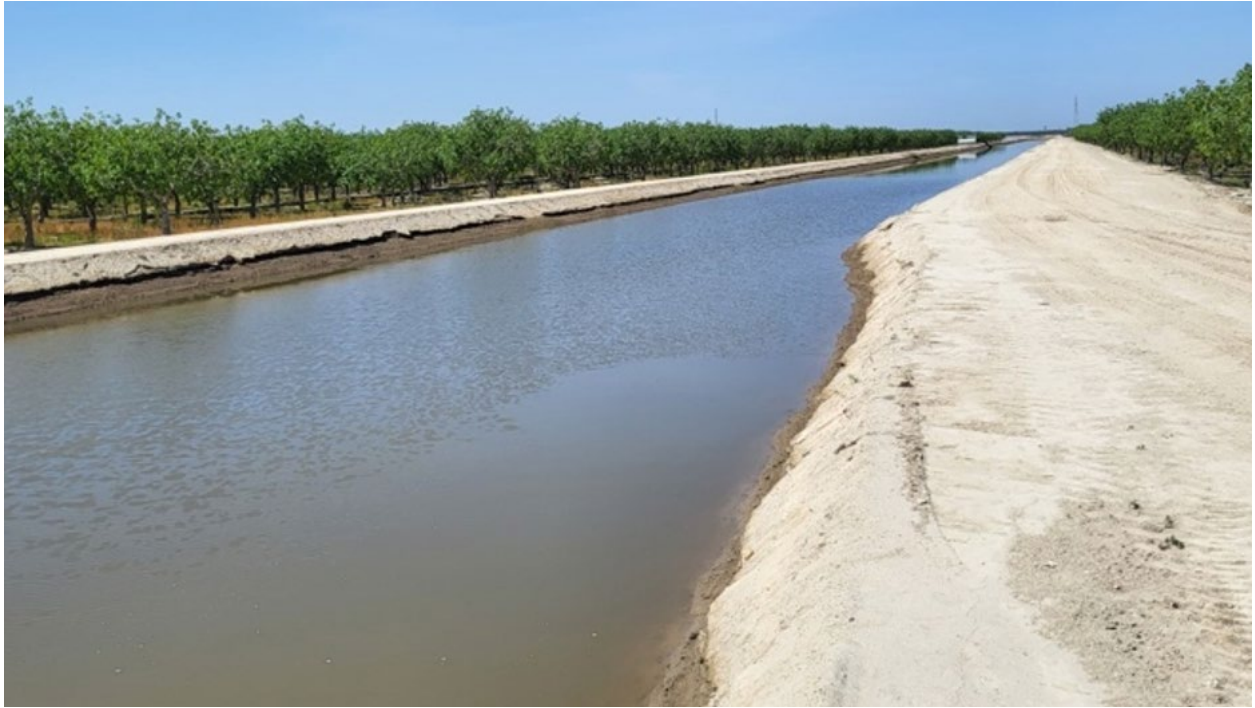
Water in an unlined canal conveyance system with pistachios orchards on either side.

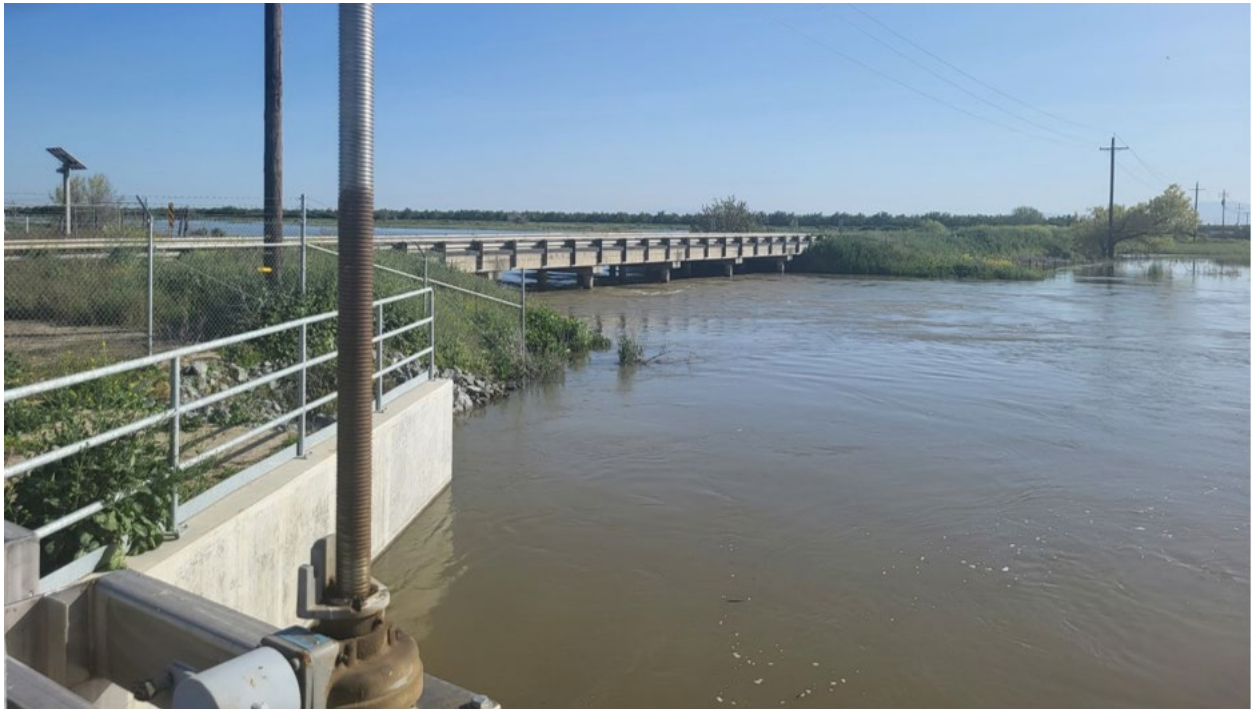
The diversion point of water on the Kings River North Fork canal into the Terranova Ranch.

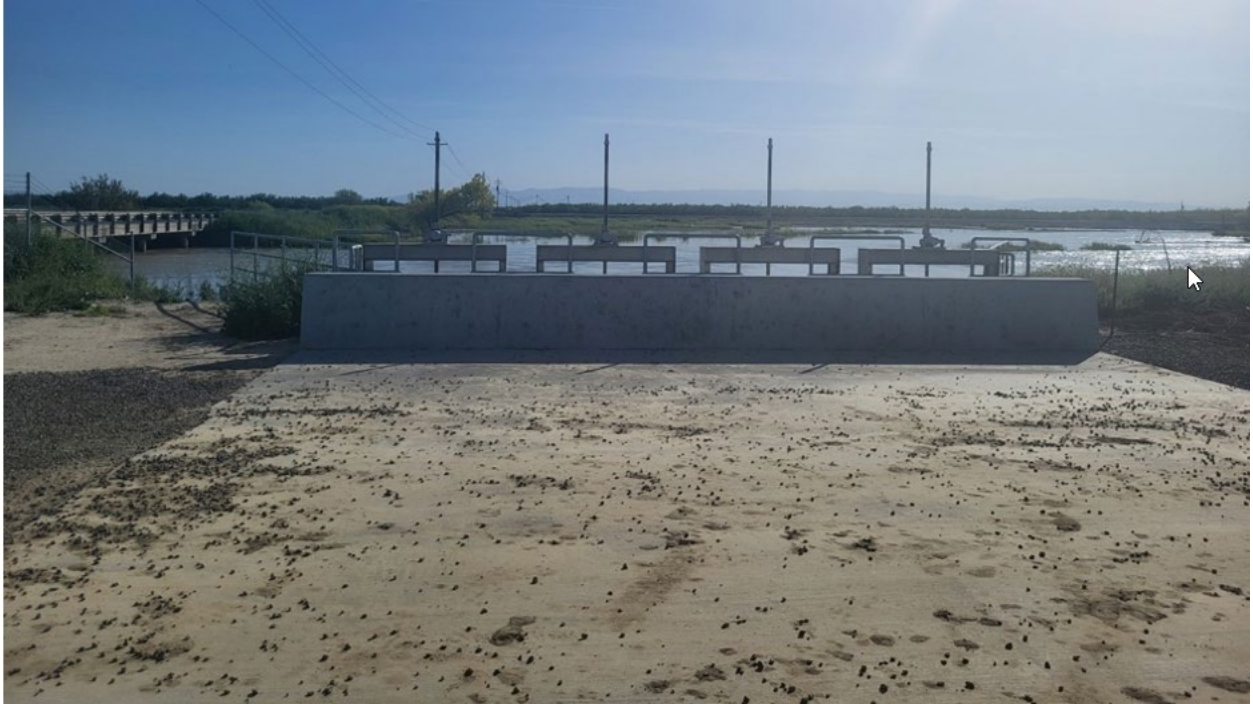
Four turnout gates on the Kings River diverting water into the Terranova Ranch canal system.

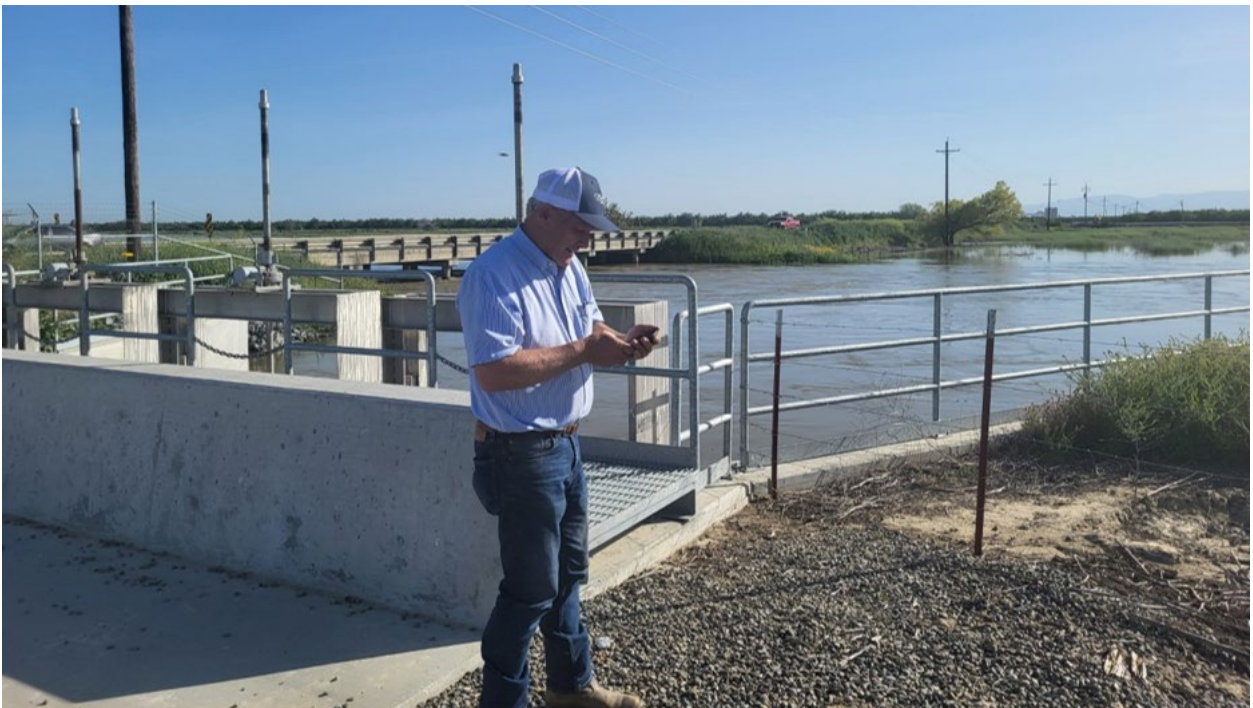
Mr. Cameron, using his computer telemetry to control the height of the turnout flood gates.

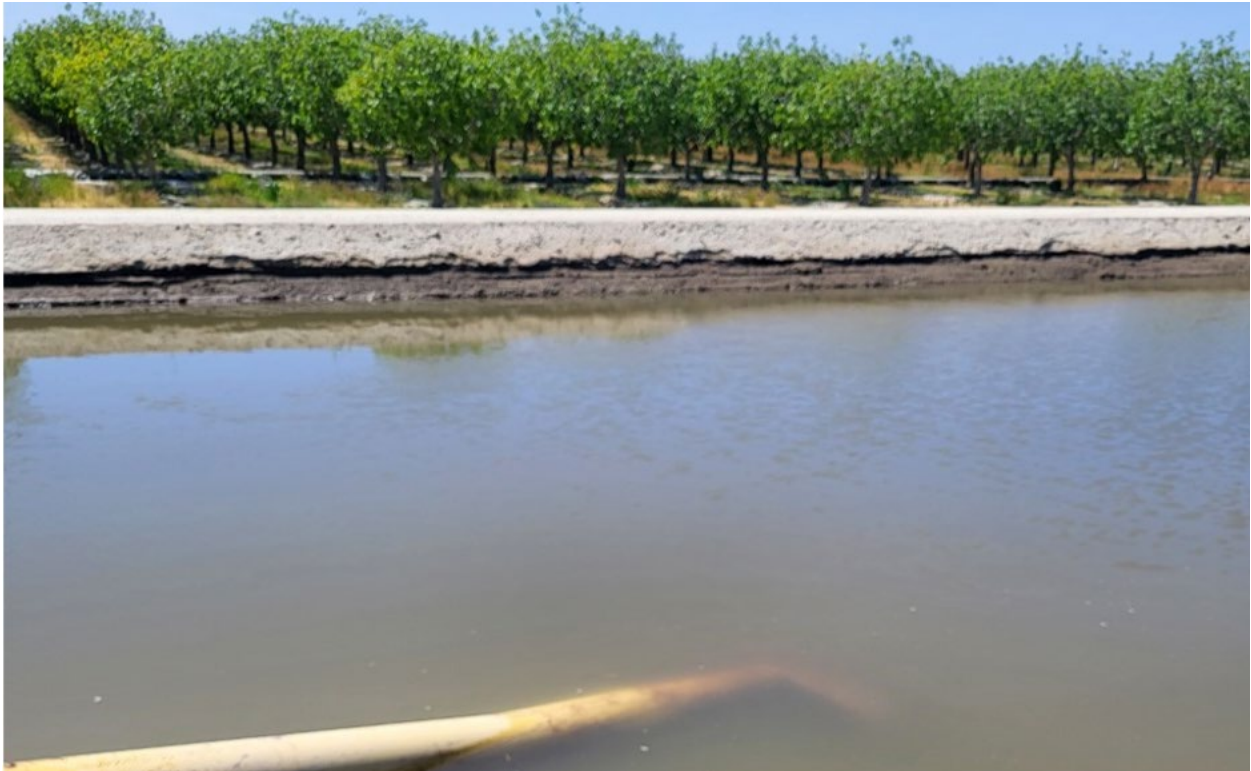
Pumping water from internal canal into a pistachio orchard through an intricate conveyance system.

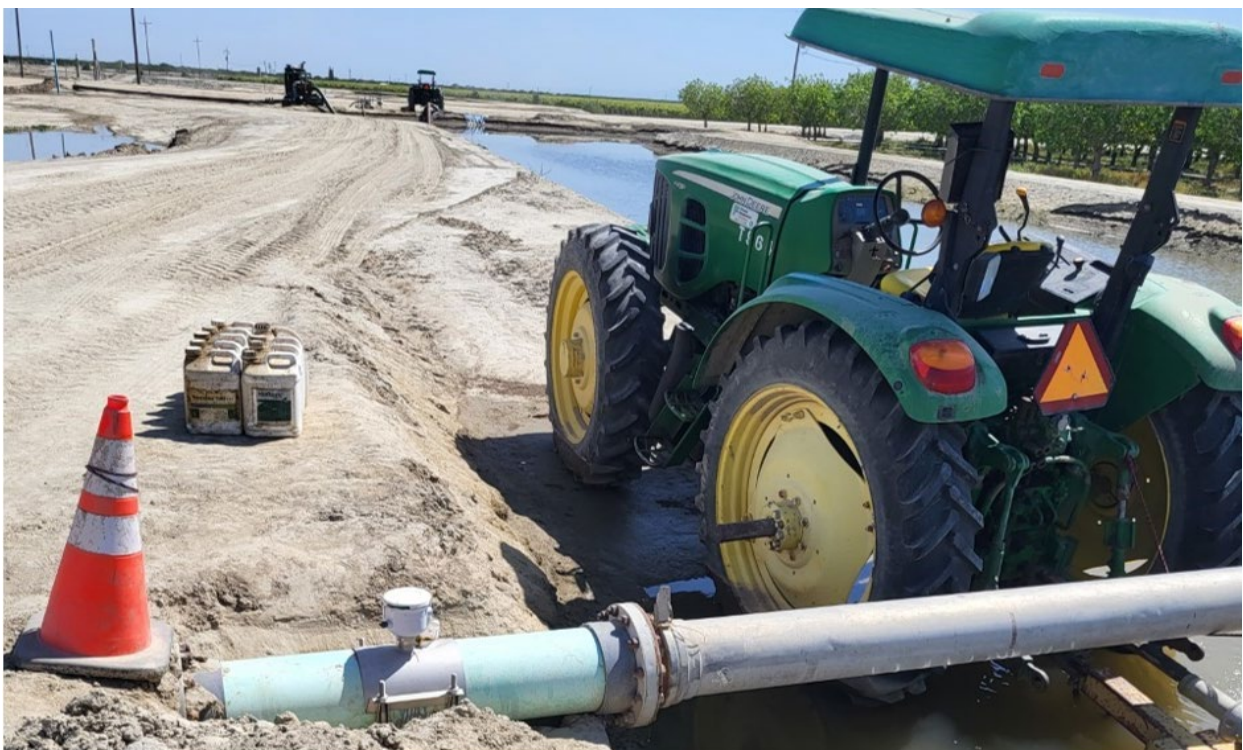
Water metered and pumped from internal canal into a pistachio orchard.

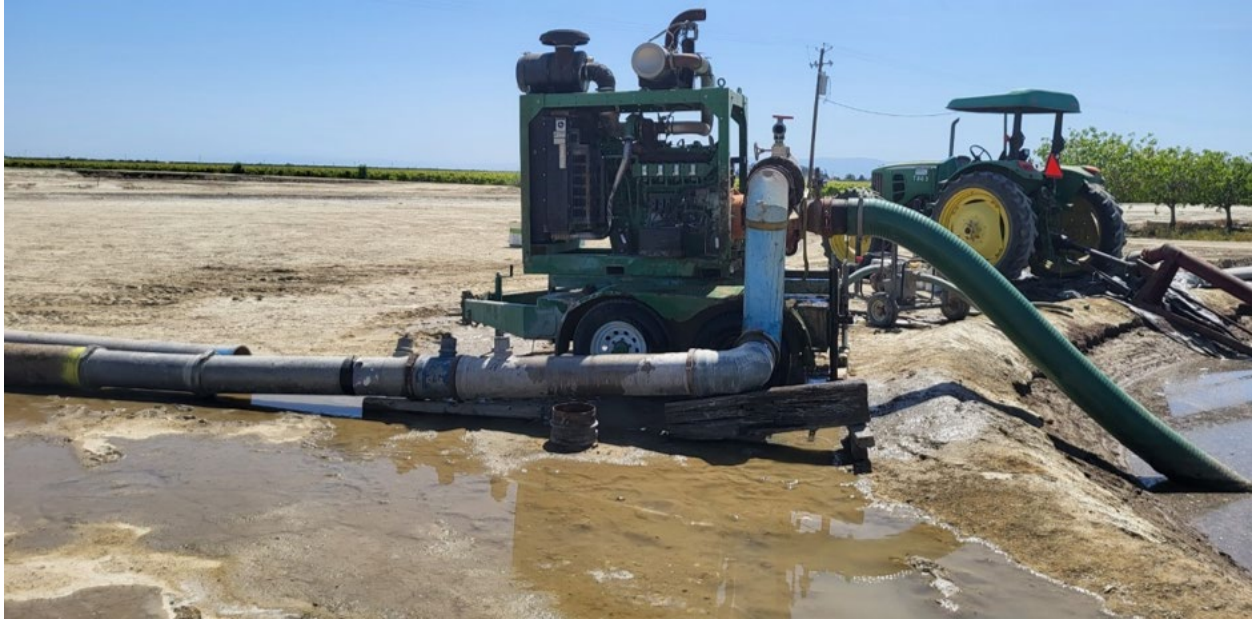
Water is being pumped using diesel power take-off (PTO) motors from the basins into the pistachio orchards and wine-grape vineyards using thousands of feet of pipe across the entire ranch to convey water to different plantings for on-farm recharge.

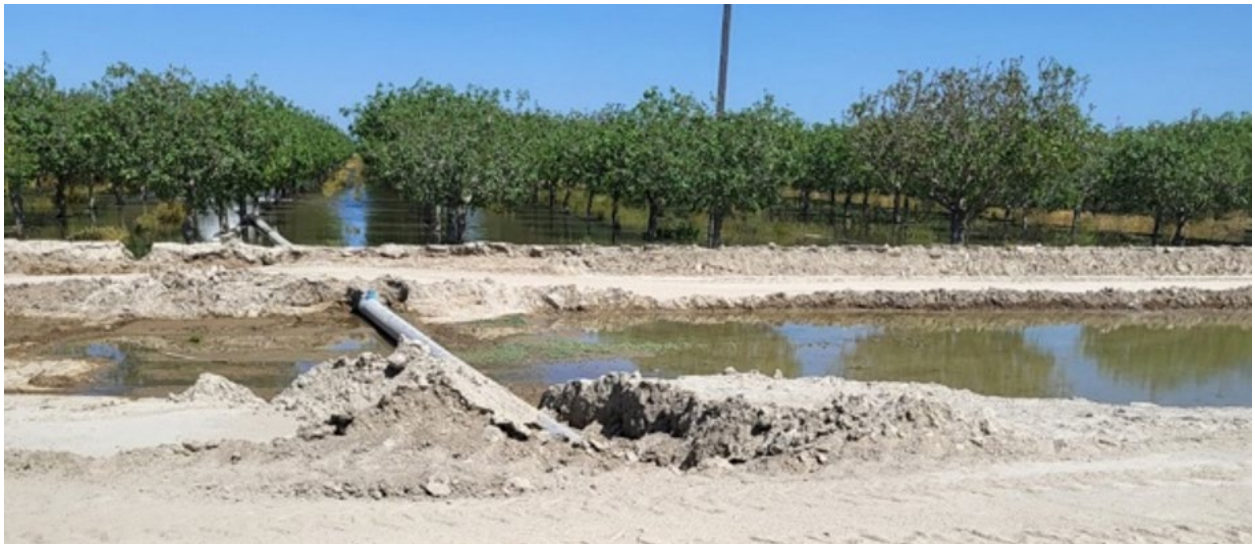
Long length of pipe used to convey water from internal unlined canal ditches with water pumps into a pistachio orchard.

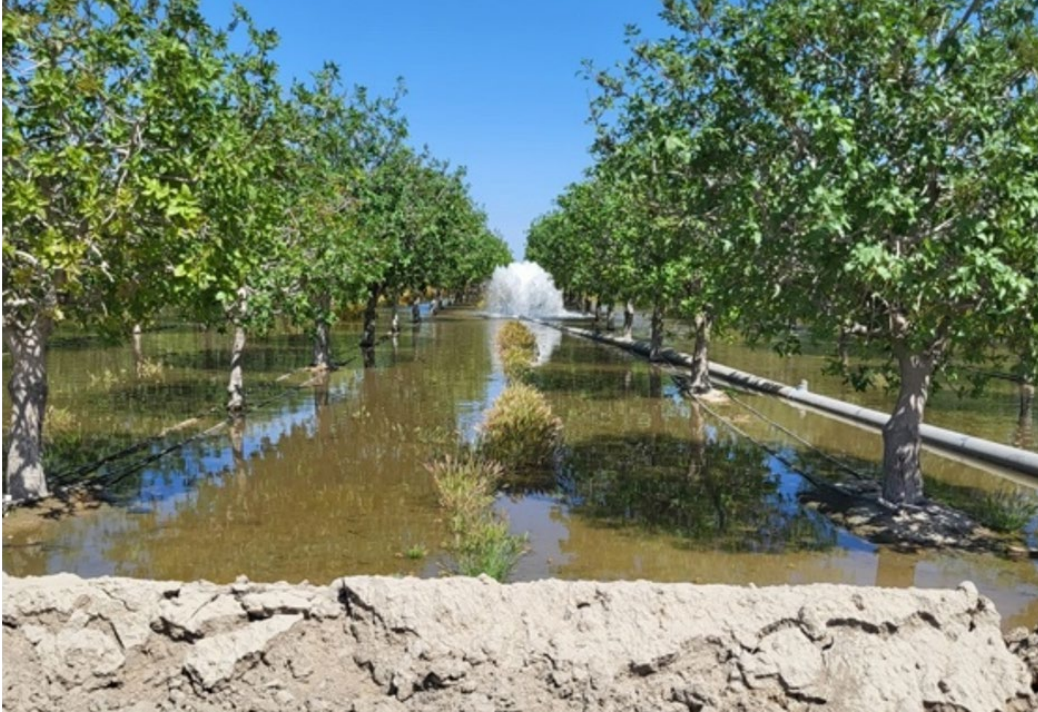
On-farm recharge in pistachio orchard (April 26, 2023) showing complete spring leaf out and trees already in full bloom.

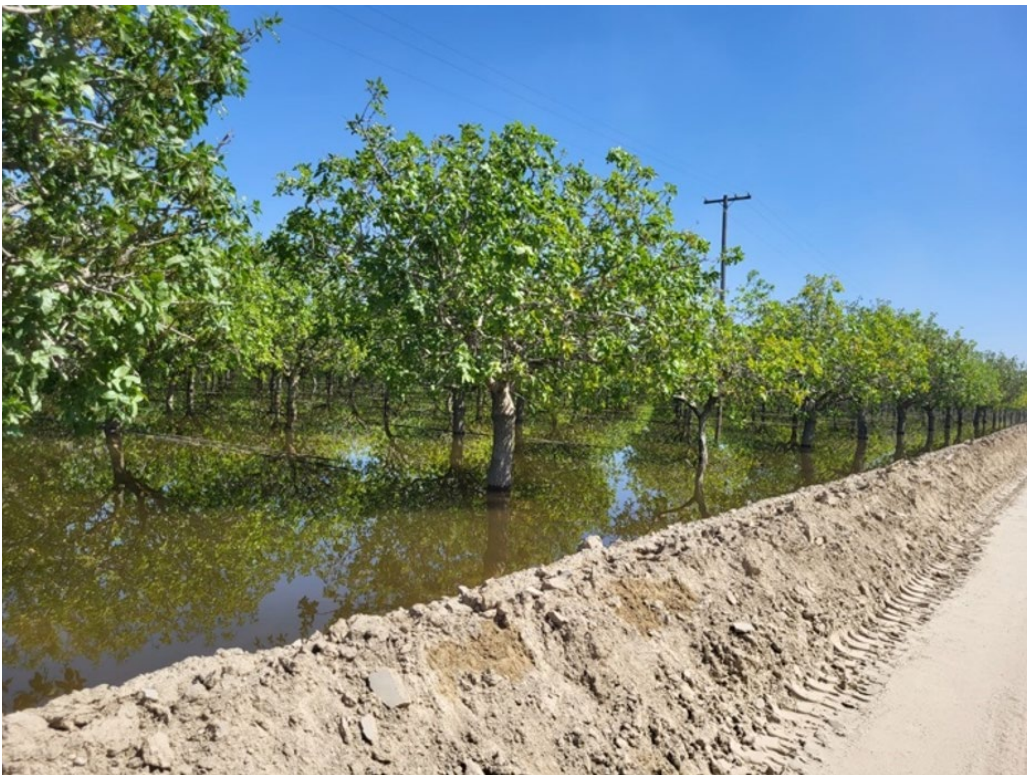
Recharge on this pistachio orchard is the result of a well-planned and well-constructed farm infrastructure for an on-farm basin storage and water conveyance delivery system.
